NMOS BULLETIN

A SURVEY OF BIRD-BUILDING COLLISIONS AND BUILDING CHARACTERISTICS AT THE UNIVERSITY OF NEW MEXICO

SUPPLEMENTARY INFORMATION

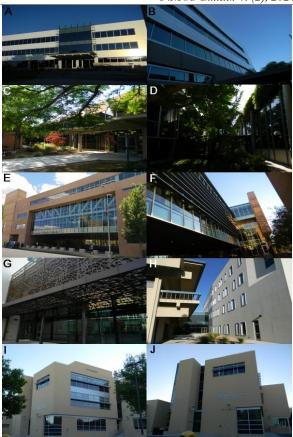
Figure S1. Buildings with the highest survey casualties. **A, B**: Farris Engineering Center; **C, D**: College of Education; **E, F**: George Pearl Hall; **G, H**: McKinnon Center for Management; and **I, J**: Science & Math Learning Center. All these buildings have high glass area with sky and surrounding vegetation heavily reflected in the windows with some vegetation very close to the windows. Photos © Danica Simmons.

#	Building Name	Building Size (floor space, m²)	Glass Area (%)	Uninterrupted Reflectivity	Survey Casualties
1	Centennial Engineering	13,405	50	High	0
2	College of Education	8253	55	High	4
3	Farris Engineering Center	7282	80	Very High	5
4	George Pearl Hall	10,301	61	High	4
5	Johnson Center	27,599	32	Medium	1
6	Journalism & Communication	3156	54	High	1
7	Logan Hall	5135	45	Medium	2
8	McKinnon Center	6017	53	High	4
9	Mesa Vista Hall	14,379	63	High	2
10	Mitchell Hall	4636	40	Medium	2
11	Popejoy Hall	34,587	28	Medium-Low	0
12	Scholes Hall	4753	66	High	2
13	Science & Math Learning Center	6936	58	High	4
14	Social Sciences & Economics	4971	50	High	1
15	Student Union Building	15,013	56	High	0
16	Collaborative Teaching & Learning	2405	50	High	3
17	UNM Bookstore	4709	26	Low-Medium	1

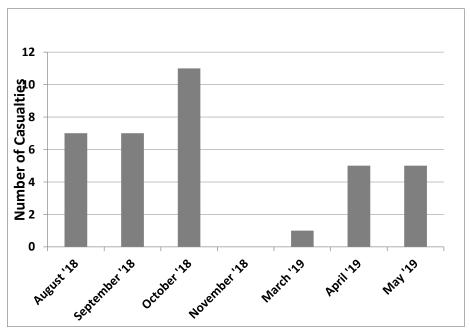
Figure S4. Casualties recorded per month across the survey.

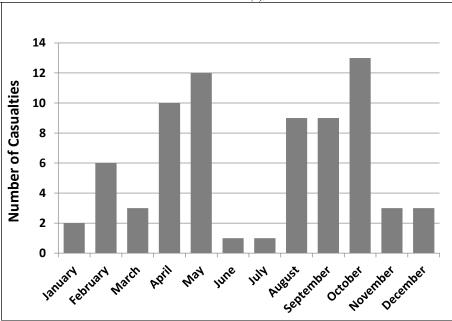
Figure S5. All campus casualties recorded (survey and ARCTOS) and the months each casualty was recorded.
